# Summer Training Project Report

**Tata Motors Limited**

**Lucknow Plant**

**Problem resolution after  
proper Root Cause Analysis of the part  
Assembly Cross Member (2632 3120 0126) from  
M/s Mitter Fasteners**

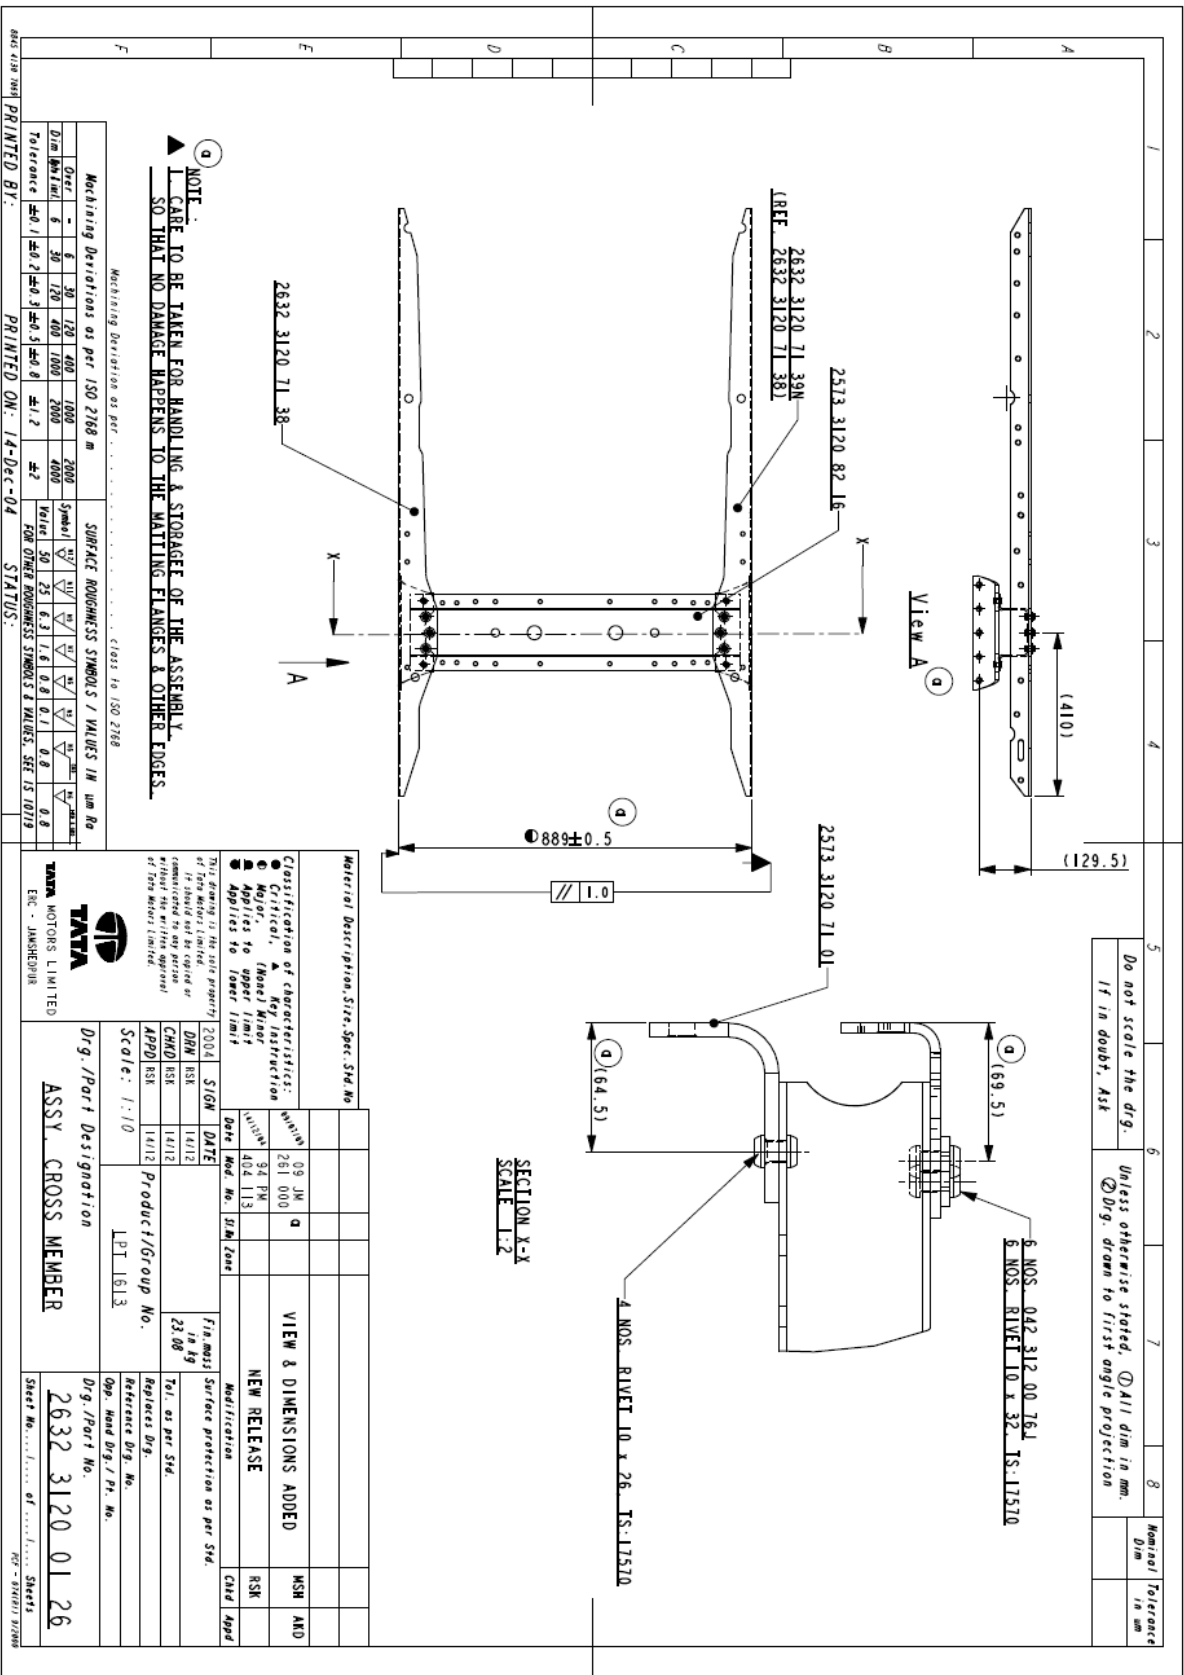
Dwg./Part No. 2632 3120 01 26

Dwg./Part Designation: ASSY. CROSS MEMBER

Product/Group No. LPT 1613

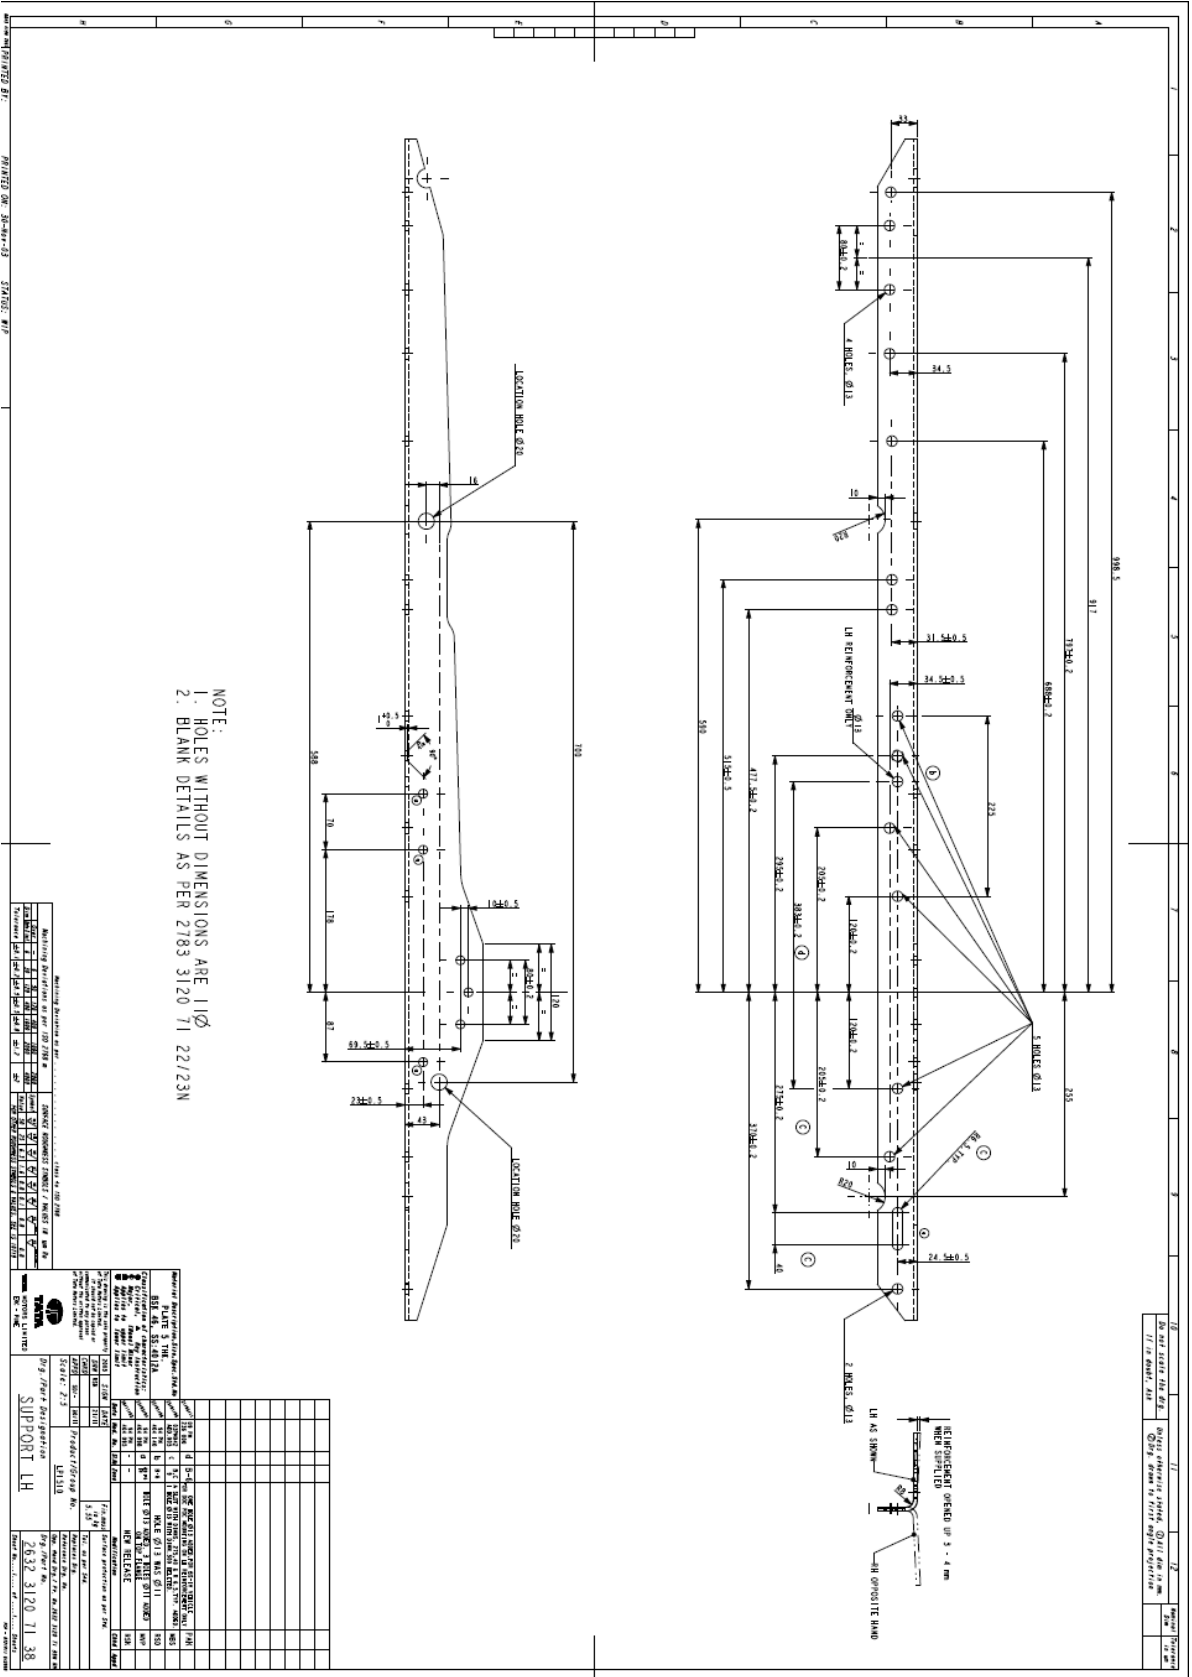
## 2632 3120 71 38/39

# Support LH/RH

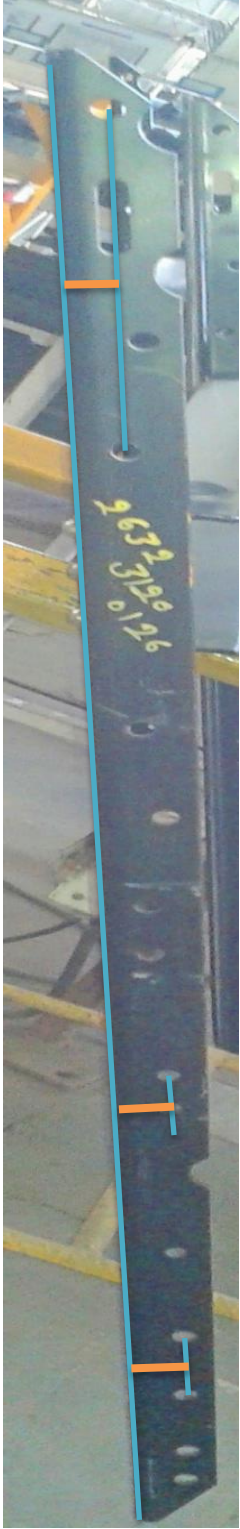
Erroneous Dimensions

Dimensions **31.5**, **24.5**, **34.5** mm of hole from end on Support LH/RH are Not OK and hence holes require reaming for assembly.

Induced by variation in Bend angle along the length of the part.

New punch is perfectly linear and hence dimensions 31.5, 24.5, 34.5 mm are OK in produced parts.

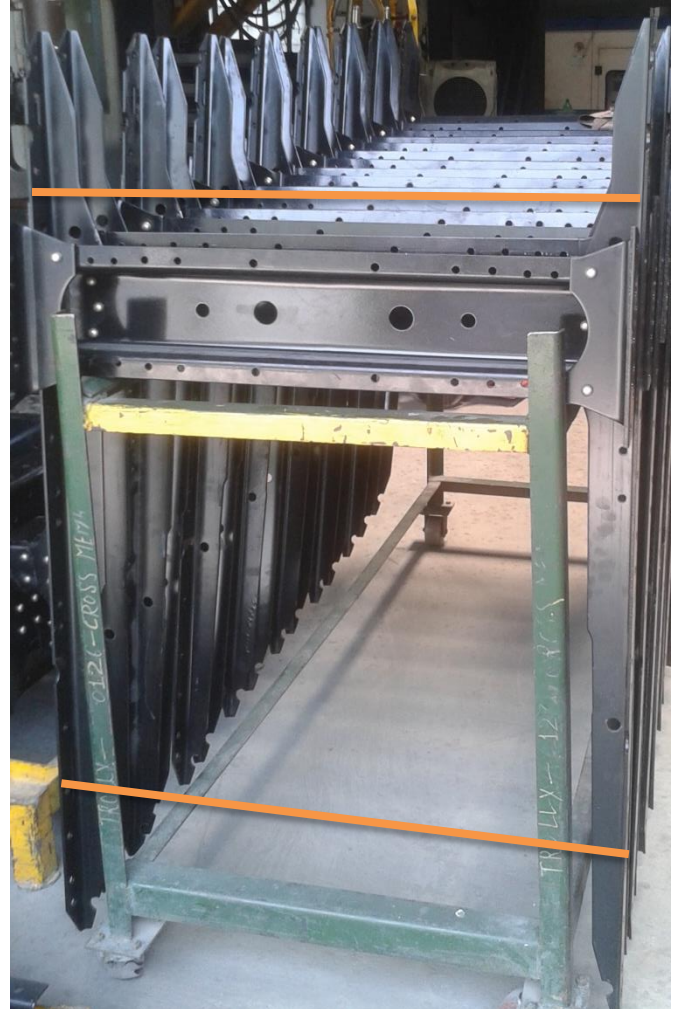
Erroneous Dimensions

Dimension **889 ± 0.5** is not uniform along the entire length of Support LH/RH.

Support LH and Support RH are not parallel to each other.

This redesigned fixture ensures the uniformity of  $889 \pm 0.5$  mm dimension along the entire length.

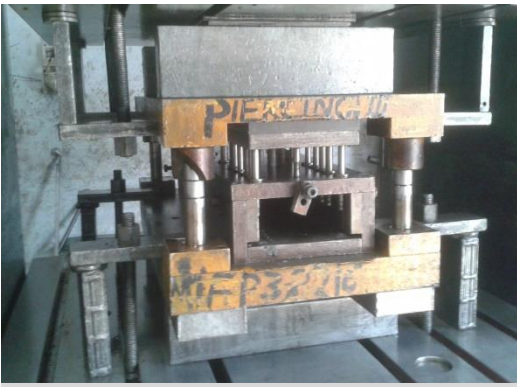
Die for Piercing fixed with stoppers and locating pins

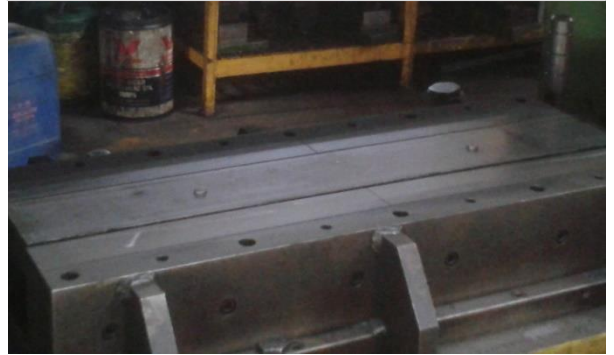
Die for Drawing/Bending with locating pins

**All Die and Fixtures have sufficient number of Stoppers and Locating pins for reducing the probability of error in manufacturing.**

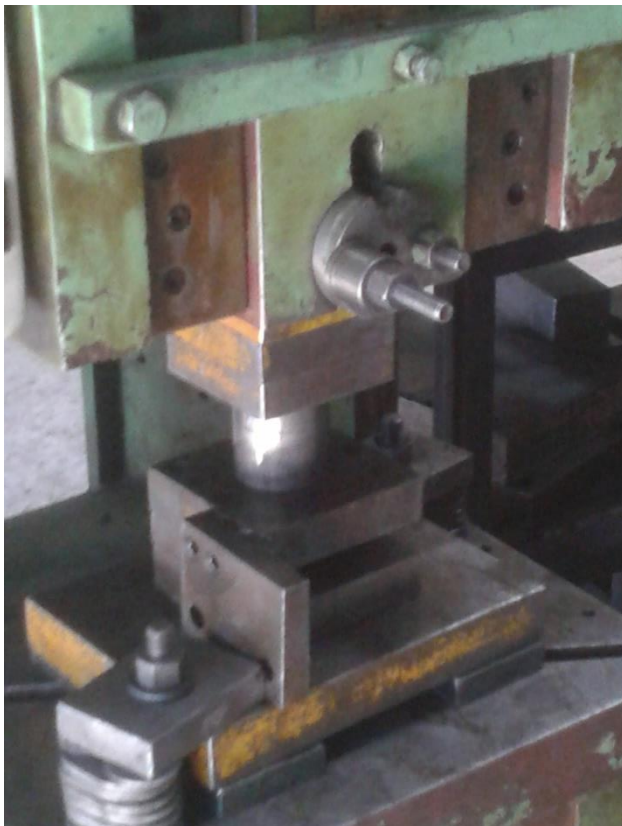
Notching tool with stopper

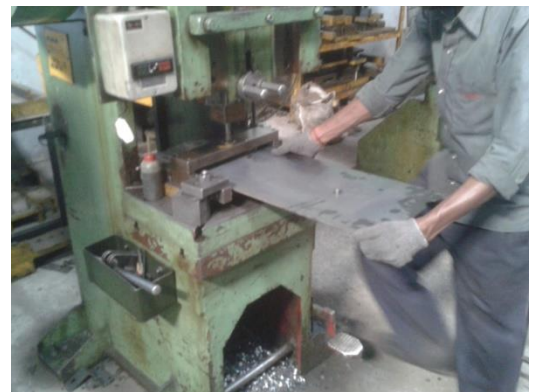
Piercing with locating pins and stoppers

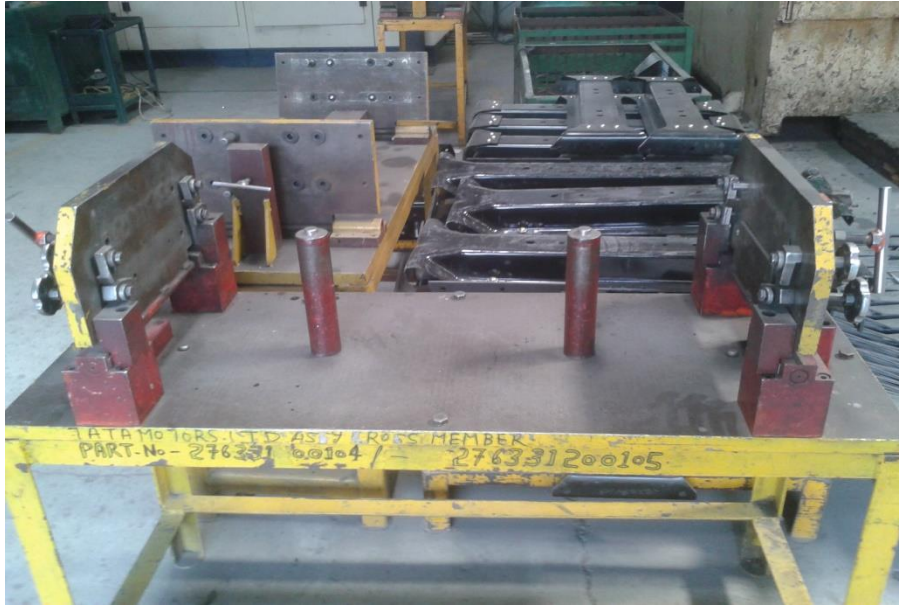
BEFORE

- Regular inspection of parts **after every process** helps to identify defect causing processes.
- Bending in part 2632 3120 **71 38/39** on brake press was producing variation in flatness of part.  
**Punch was found to be worn out.**
- Riveting procedure done with the help of a fixture was **unable to ensure that 2632 3120 71 38 and 39 were parallel** to each other after assembly.

Fixture is quite small for handling long parts such as 2632 3120 71 38/39

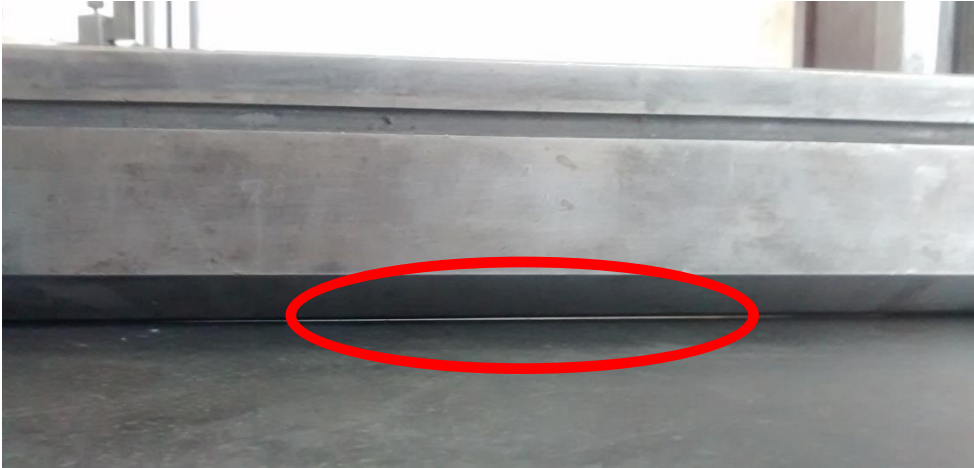
BEFORE

Punch has worn out and hence produces unlevelled parts.

This variation in flatness causes the holes to shift from desired position.
